## ASLA Brings Nature to its Roof

### DEMONSTRATION ROOF

The American Society of Landscape Architects decided its own roof would make an excellent demonstration model

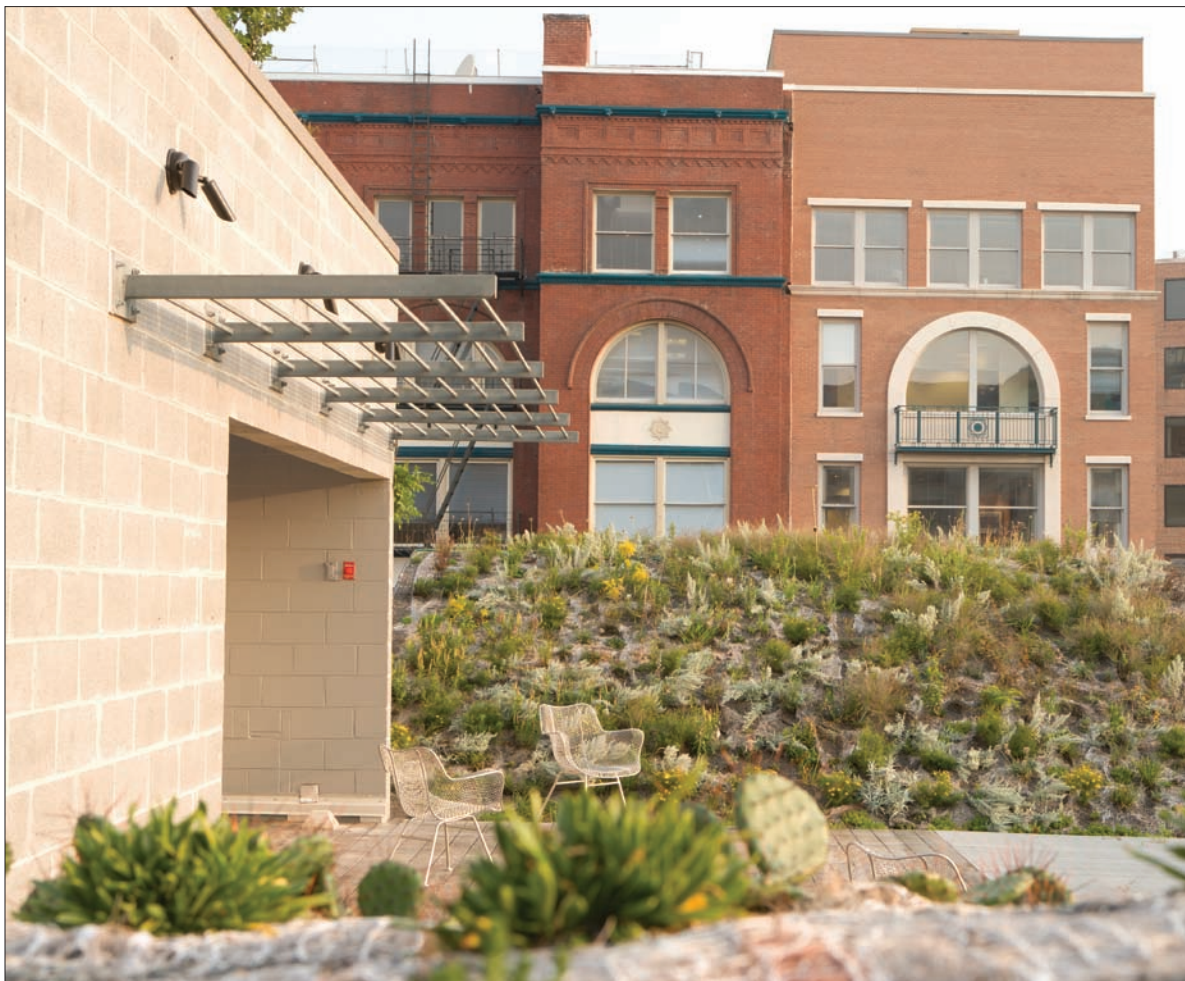
Surrounding the two highly sloped areas at deck level is a third green roof system covered by metal grating that allows visitors to walk only a few inches above the extensively (3-in. deep) planted material. The roof also features a small observation deck as well as an open pavilion (that houses a stairwell for access) covered with various types of intensive green roof material.

Constructing the roof's two wave sections required the use of innovative techniques and new assembly materials to meet the design requirements of the two highly sloped areas. The waves were shaped with rigid insulation then covered by lightweight aggregate. The aggregate was first covered with a filter fabric and then GardNet, a new soil stabilization system for green roofs developed by American Hydrotech. The waves are each framed by a steel structure and anchored by a system of steel cables. "A 2:1 slope (10°) is very steep for general outside landscape purposes," Counts says. "But because of this new soil stabilization system, we could have actually made the waves even steeper. It's really interesting and a bit counter-intuitive, because green roof planting medium looks basically like small-sized gravel—something that would easily slide."

The dominant features of the design are two highly sloped areas, or "waves," covered with extensive and semi-intensive plantings. "The concept was actually more about being in-between those slopes, and how it adjusts one's relationship with the horizon," Counts says. "It creates this green horizon in relationship with the city. To my knowledge, this may be one of the first projects that uses green roof materials to make a held physical space, like you're in a small green valley."

building next to a green roof, you don't typically get the benefit of seeing it. In our design process, the waves were calibrated through computer modeling so that a portion can be seen from street level."
